# European Radon Solutions Database

### Case Study

CZ/CS/01

**SUB-SLAB DEPRESSURIZATION BASED ON PERFORATED TUBES DRILLED FROM CELLAR**

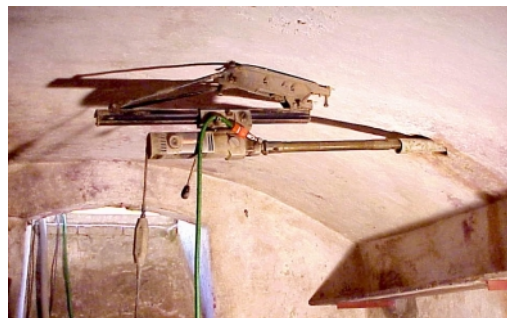
Drilling of perforated tubes from the cellar into the sub-floor region

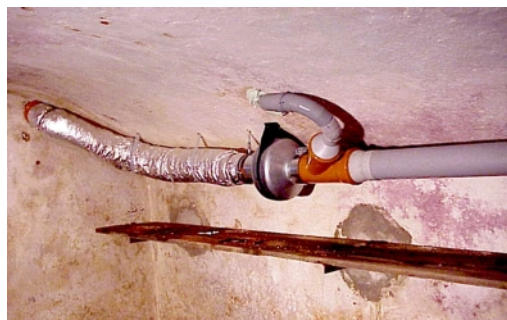
All drilled tubes are connected with a PVC-U exhaust pipe to a fan. A silencer is mounted between the fan and the outlet.
