# European Radon Solutions Database

## Existing Buildings

UK/CS/001

Multiple radon sump system

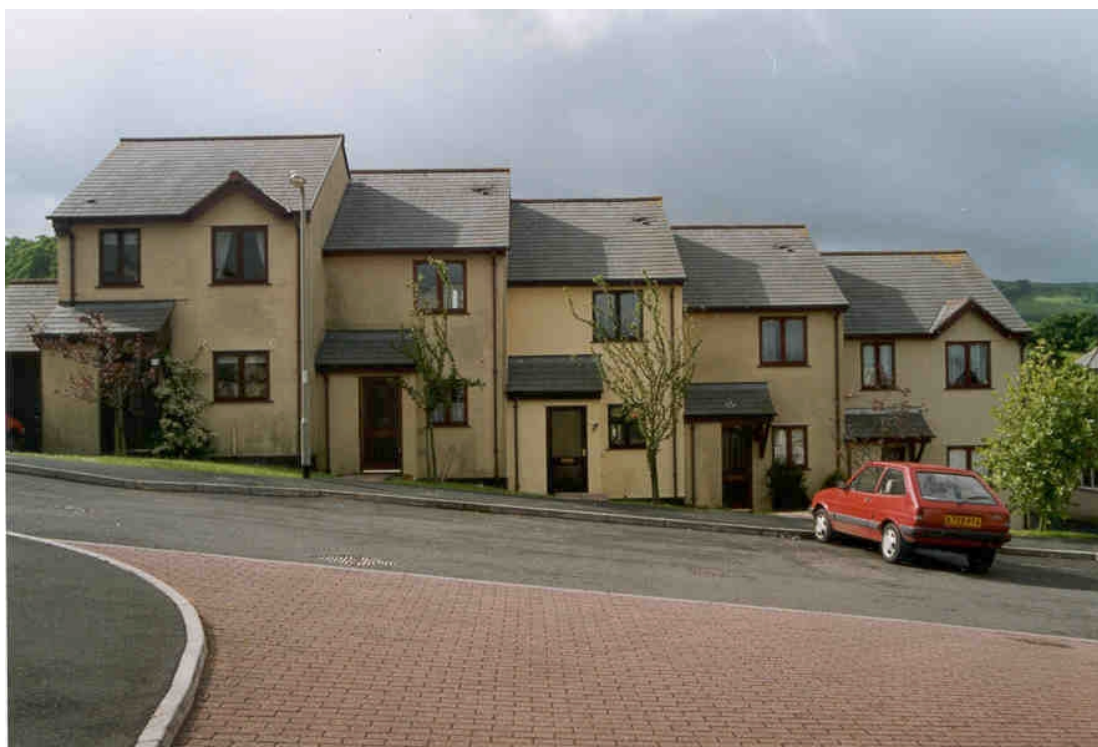
## Illustration

houses

This project comprises a terrace of five houses, built in 1988, located in Devon in Southwest England. Constructed with rendered concrete block work cavity walls and in-situ concrete ground floor.

Initially only houses A and E were monitored as part of the newbuild study. But when it was found that these two had elevated levels  $1477 \text{ Bq/m}^3$  and  $3392 \text{ Bq/m}^3$  respectively, negotiations were opened with the owners of all five houses to see whether a communal approach might be applied to reducing the radon levels. It was anticipated that when all five houses were monitored they would all have similar radon levels, making a sump system in House C the most appropriate solution. On monitoring it was found that this was not the case, in fact the central house, House C, had a radon level below the UK recommended Action Level of  $200 \text{ Bq/m}^3$ . Therefore we could not justify installing a system within this house. Instead two sump systems were provided, one at each end of the block in Houses A and E.
