European Radon Solutions Database
Prepared by
: ERRICCA 2 European Radon Research and Industry Collaboration Concerted Action
European Commission Contract N°: FIRI-CT-2001-20142

# **Existing Buildings**

Sheet N° **Case Study**

Type Radon sump system

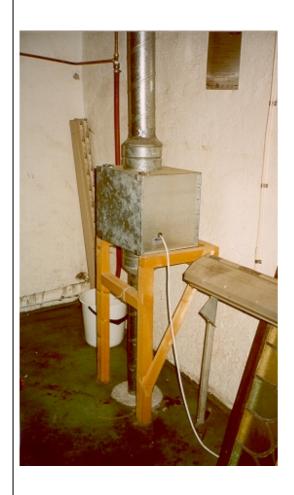
# Illustration

The house was built in 1936, two floors with cellar. Slab on ground construction with brick walls. Natural draught ventilation with a kitchen fan. The house is located on a normal-risk soil, with high-risk areas close by.

The selected mitigation method in this case is a sub-slab suction system. This system is homemade, with one suction point located in the middle of the slab. A 75 W electric fan draws air from the soil beneath the slab. The fan can be regulated. The air is exhausted outside the house. The fan is insulated not to make noise.

The original level of radon was 1440 Bq/m<sup>3</sup>. After the sub-slab suction system was installed the levels have varied between 70 and 110 Bq/m<sup>3</sup> depending on the adjusted effect of the fan. Usually the effect has been set on one fourth of its maximum.

There have been some problems maintaining a low radon level due to the fan that has broken down at a few occasions. The air exhaust in this case is about 0,5 meters above ground at the same vertical level as the house wall. This construction could in worst case lead the radon containing air into the house again, but fortunately there is no window or air intake close to the exhaust pipe.

The fan can be accelerated to receive a bigger reduction in radon level.
