# European Radon Solutions Database

### Case Study

CZ/CS/04

**EXTERNAL MINI SUMP SYSTEM**

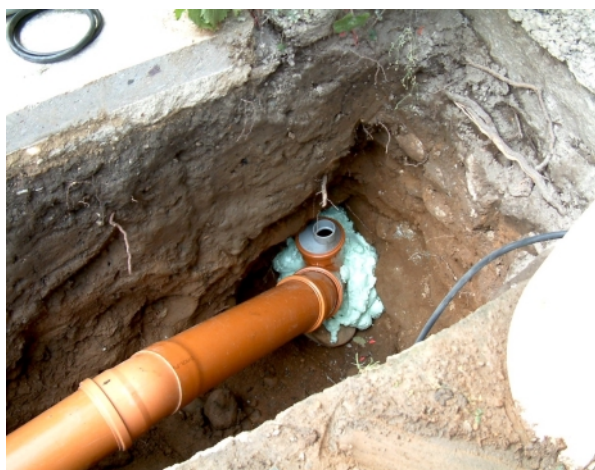
Sump excavated under the external footing. To prevent air and pressure leakage from the sump to the surrounding soil outside the house, the exhaust pipe is sealed with PU foam. The branch from the pipe was used for inserting of various measuring probes into the sump.

The soil ventilation system is based on a single sump excavated from the house exterior. The sump was placed under the living room behind the external foundation. The sump was designed to service only the underfloor space on one side of the cellar, i.e. beneath kitchen, living room and bedroom. The underfloor space beneath the study room is located on the opposite side of the cellar and cannot be affected by the sump. The fan that draws air from the sump is located on the garden boundary and is hidden behind the flowers.

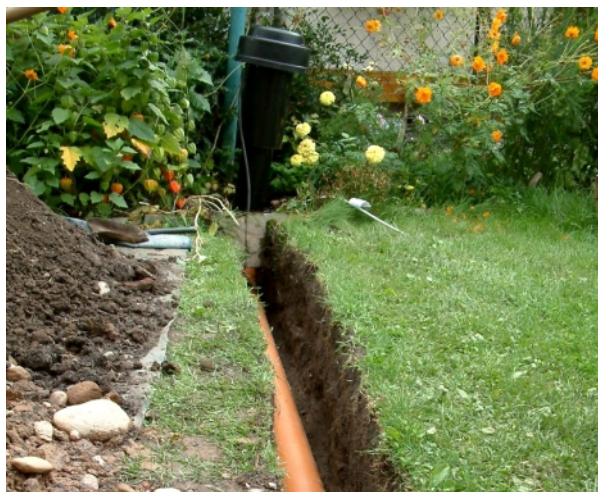
The exhaust pipe ends with a fan that will be hidden behind the flowers.
